DEPARTMENT OF TRANSPORTATION

Quality Assurance and Source Inspection

Contract #: 04-0120F4Cty: SF/ALA Rte: 80 PM: 13.2/13.9File #: 69.28**WELDING INSPECTION REPORT****Resident Engineer:**Pursell, Gary**Address:** 333 Burma Road**City:** Oakland, CA 94607**Report No:** WIR-002763**Date Inspected:** 28-May-2008**Project Name:** SAS Superstructure**OSM Arrival Time:** 700**Prime Contractor:** American Bridge/Fluor Enterprises, a JV**OSM Departure Time:** 1700**Contractor:** Zhenhua Port Machinery Company, Ltd (ZPMC), Changxing Island **Location:** Shanghai, China**CWI Name:** Sun Wei**CWI Present:** Yes No**Inspected CWI report:** Yes No N/A**Rod Oven in Use:** Yes No N/A**Electrode to specification:** Yes No N/A**Weld Procedures Followed:** Yes No N/A**Qualified Welders:** Yes No N/A**Verified Joint Fit-up:** Yes No N/A**Approved Drawings:** Yes No N/A**Approved WPS:** Yes No N/A**Delayed / Cancelled:** Yes No N/A**Bridge No:** 34-0006**Component:** OBG**Summary of Items Observed:**

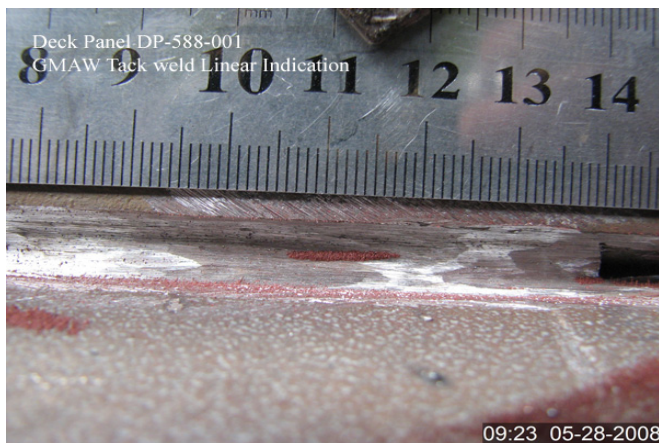
The Quality Assurance Inspector performed magnetic particle inspection to the tack welds on weld 8 of Deck Panel DP-588-001. Weld 8 contains 21 tack welds. Of the 21 tack welds, 12 appeared to contain linear indications indicative of cracks. In addition, The Quality Assurance Inspector performed magnetic particle inspection to the tack welds on weld 10 of Deck Panel DP-563-001. Weld 10 contains 21 tack welds. Of the 21 tack welds, 11 appeared to contain linear indications indicative of cracks. ABF representative Warren Buehler was notified by the Quality Assurance Inspector. Mr. Buehler stated that ABF has recommended that all the tack welds be magnetic particle tested. At completion of the Quality Assurance Inspectors shift ZPMC had begun repairing the indications by grinding and retesting by the magnetic particle testing method. Below is a digital photograph of a cracked GMAW tack weld located by the magnetic particle testing method.
